Ductile Iron Pipe Repair

Comprehensive pipe solutions

This document is designed to provide a simple guide to the repair of damaged ductile iron pipe caused primarily by handling or transportation. It does not deal with all aspects repair and assumes a general level of knowledge of ductile iron piping systems of the reader. This document should not be the only source of information. Further information can be found in other SGP documentation or by referring to qualified engineers on the subject or SGP.

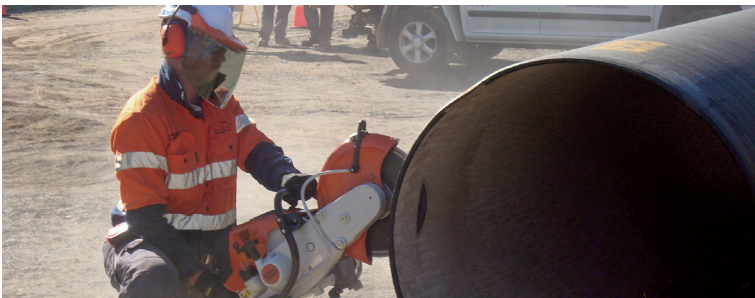
▼ Figure 6. Cutting

A hand held power saw can be used. Automated pneumatic crosscut saws should be used for larger diameters or when cutting larger numbers of pipes. Diamond or masonry blades are recommended.
